LAKE TANGLEWOOD SOUTH DAM

LAKE TANGLEWOOD NORTH DAM

CAPE GIRARDEAU COUNTY, MISSOURI

**PHASE 1 INSPECTION REPORT
NATIONAL DAM SAFETY PROGRAM**

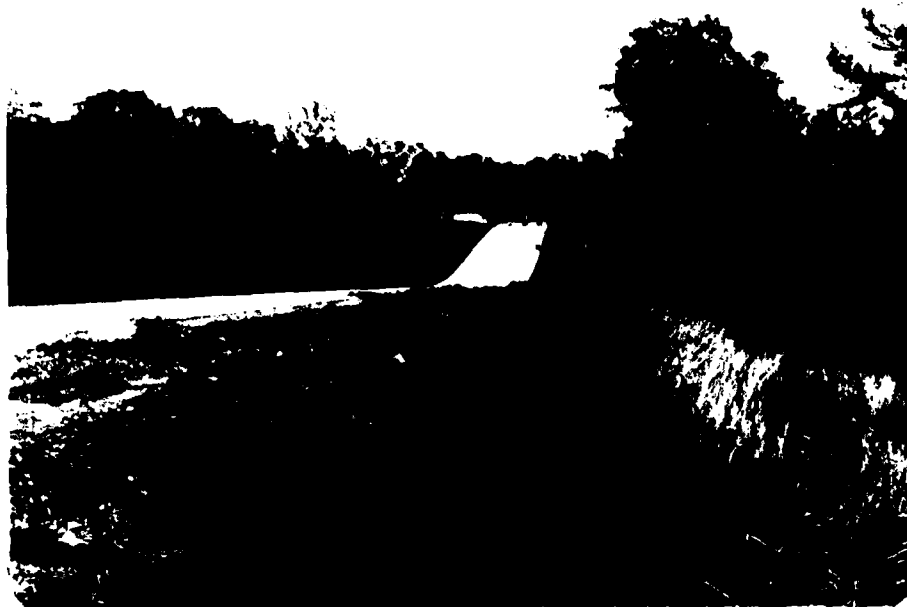
PHOTO NO. 6 - SPILLWAY CREST TAKEN FROM THE DOWNSTREAM SLOPE
ON THE RIGHT SIDE OF THE DAM

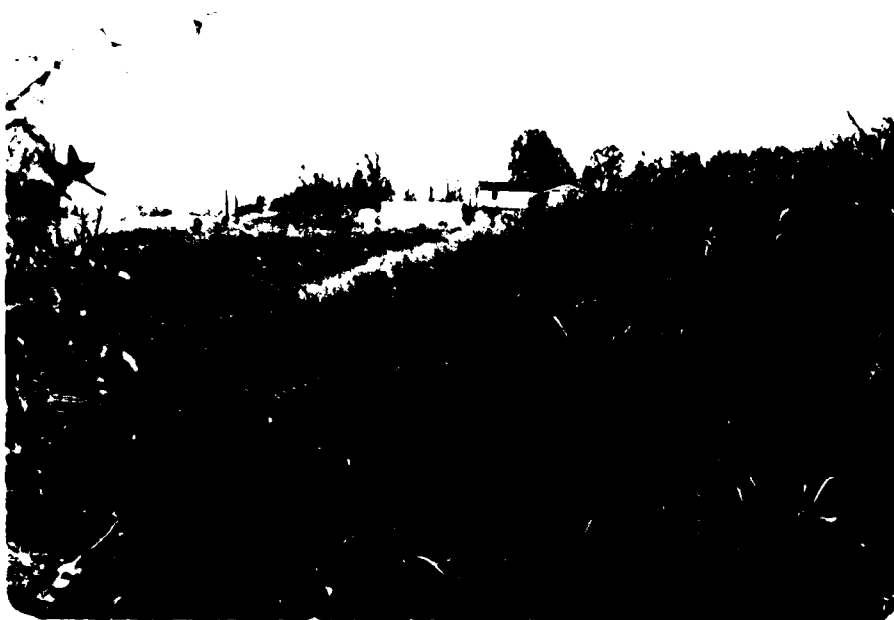
- (a) South Dam. The downstream slope is well vegetated with adapted grasses which should be mowed. No cracks, bulges, slumps, or other deformations were observed. No seepage was observed on the slope, along the toe, or in the outlet channel below the pipe spillway outlet. Some rodent activity was noted at several locations on the slope. Photos 7 and 8 show the downstream slope.

PHOTO NO. 8 - DOWNSTREAM SLOPE TAKEN FROM THE LEFT END

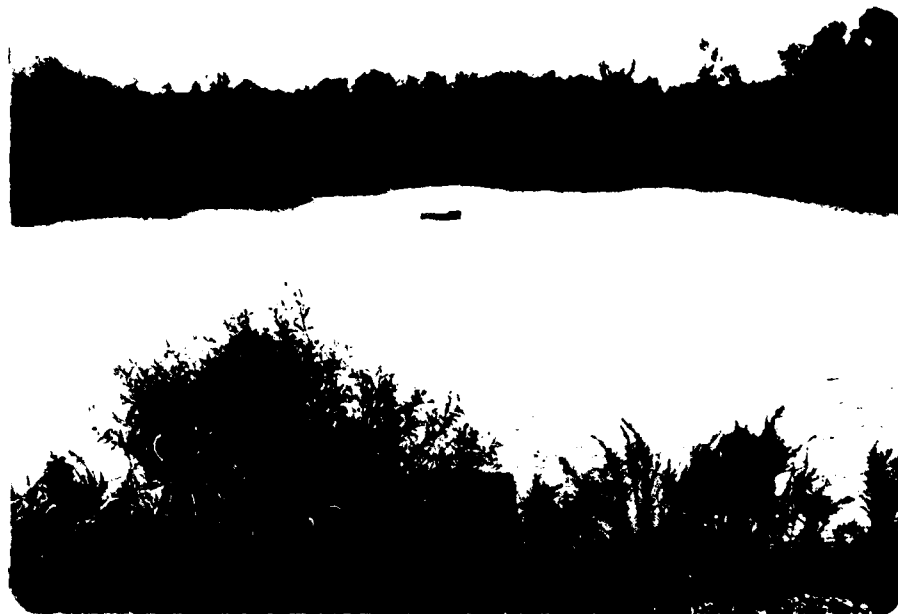
- (1) South Dam. The area around the reservoir is well vegetated. No slumps or slides were evident around the reservoir. No significant erosion was observed along the shoreline and there was no evidence of siltation. Photo No. 10 shows a portion of the reservoir. Lake Tanglewood North Dam (MO 31225) shows in the background.
- (2) North Dam. The area around the reservoir is well vegetated. No slumps or slides were evident around the reservoir. No significant erosion was observed along the shoreline. There was no evidence of siltation in the reservoir. Photo No. 30 shows a portion of the reservoir area.

PHOTO NO. 10 - LOOKING UPSTREAM OVER THE PIPE SPILLWAY.
NOTE UPPER DAM IN THE BACKGROUND

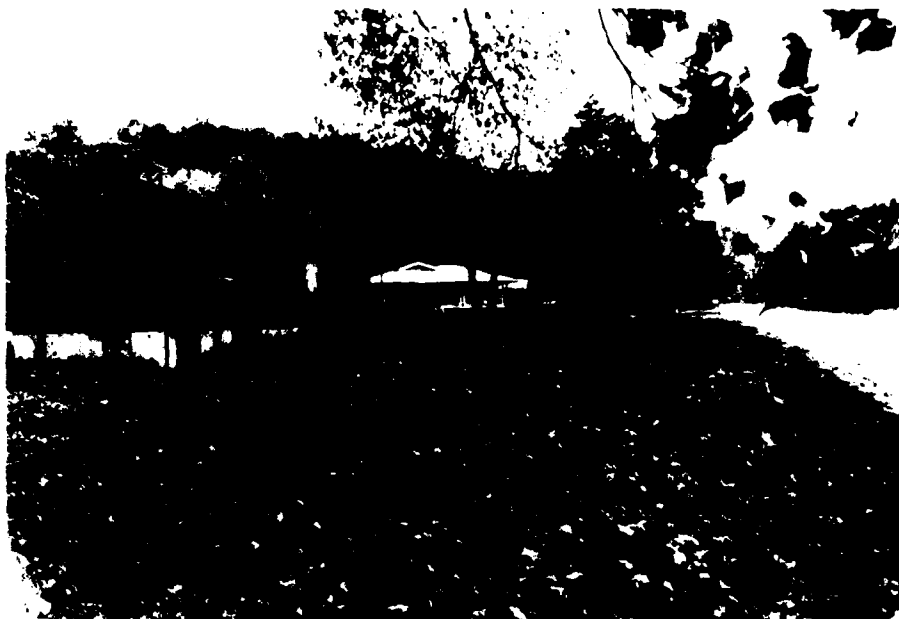
PHOTO NO. 22 - THREE HOUSES ON THE SOUTH SIDE OF THE ROAD
ABOUT 0.5 MILES DOWNSTREAM OF DAM

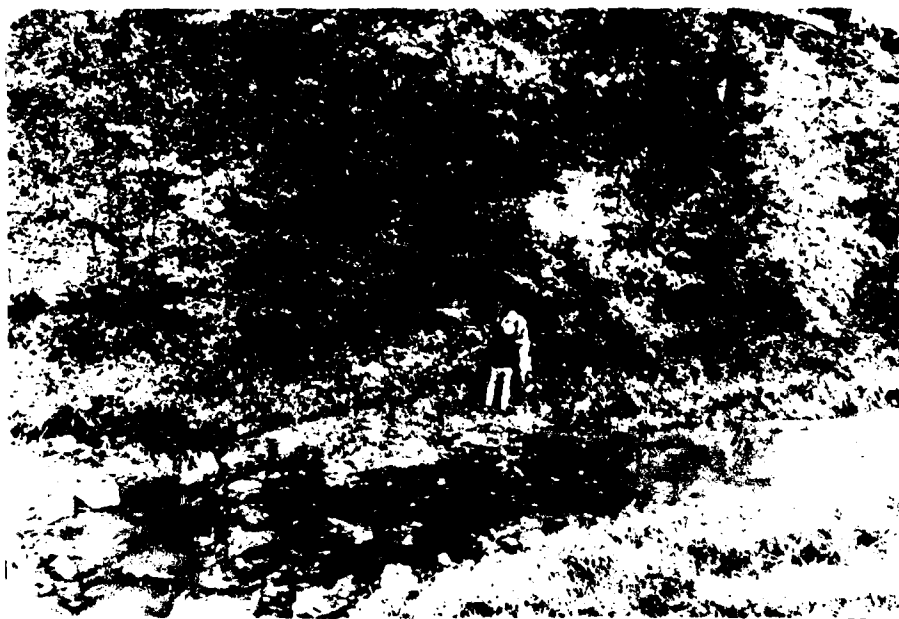
PHOTO NO. 23 - SHALEY LIMESTONE EXPOSED IN CREEK BED OF JUDEN
CREEK ABOUT 3/4 OF MILE DOWNSTREAM OF DAM

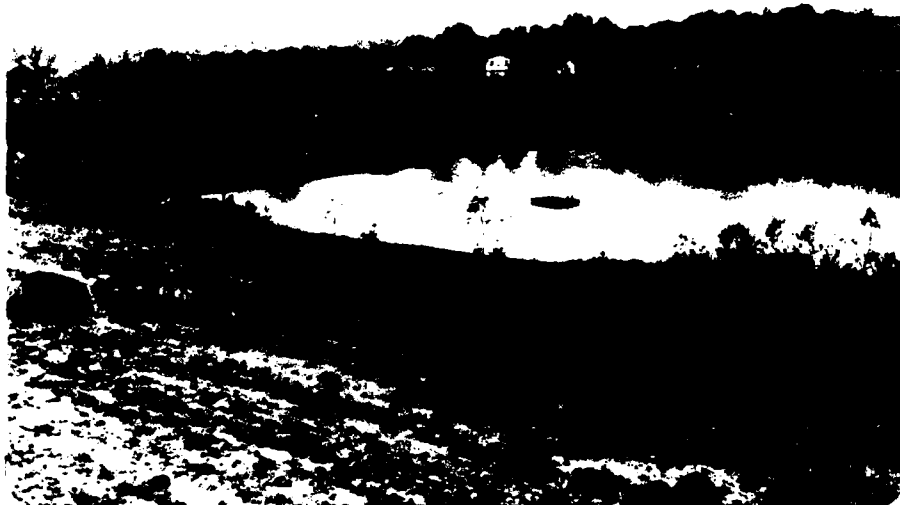
PHOTO NO. 24 - OVERVIEW TAKEN FROM THE LEFT SIDE
